## NORTHWAY (ORT)

## 2004 Alaska Airport Pavement Condition Report

# **NORTHWAY AIRPORT - 2004**

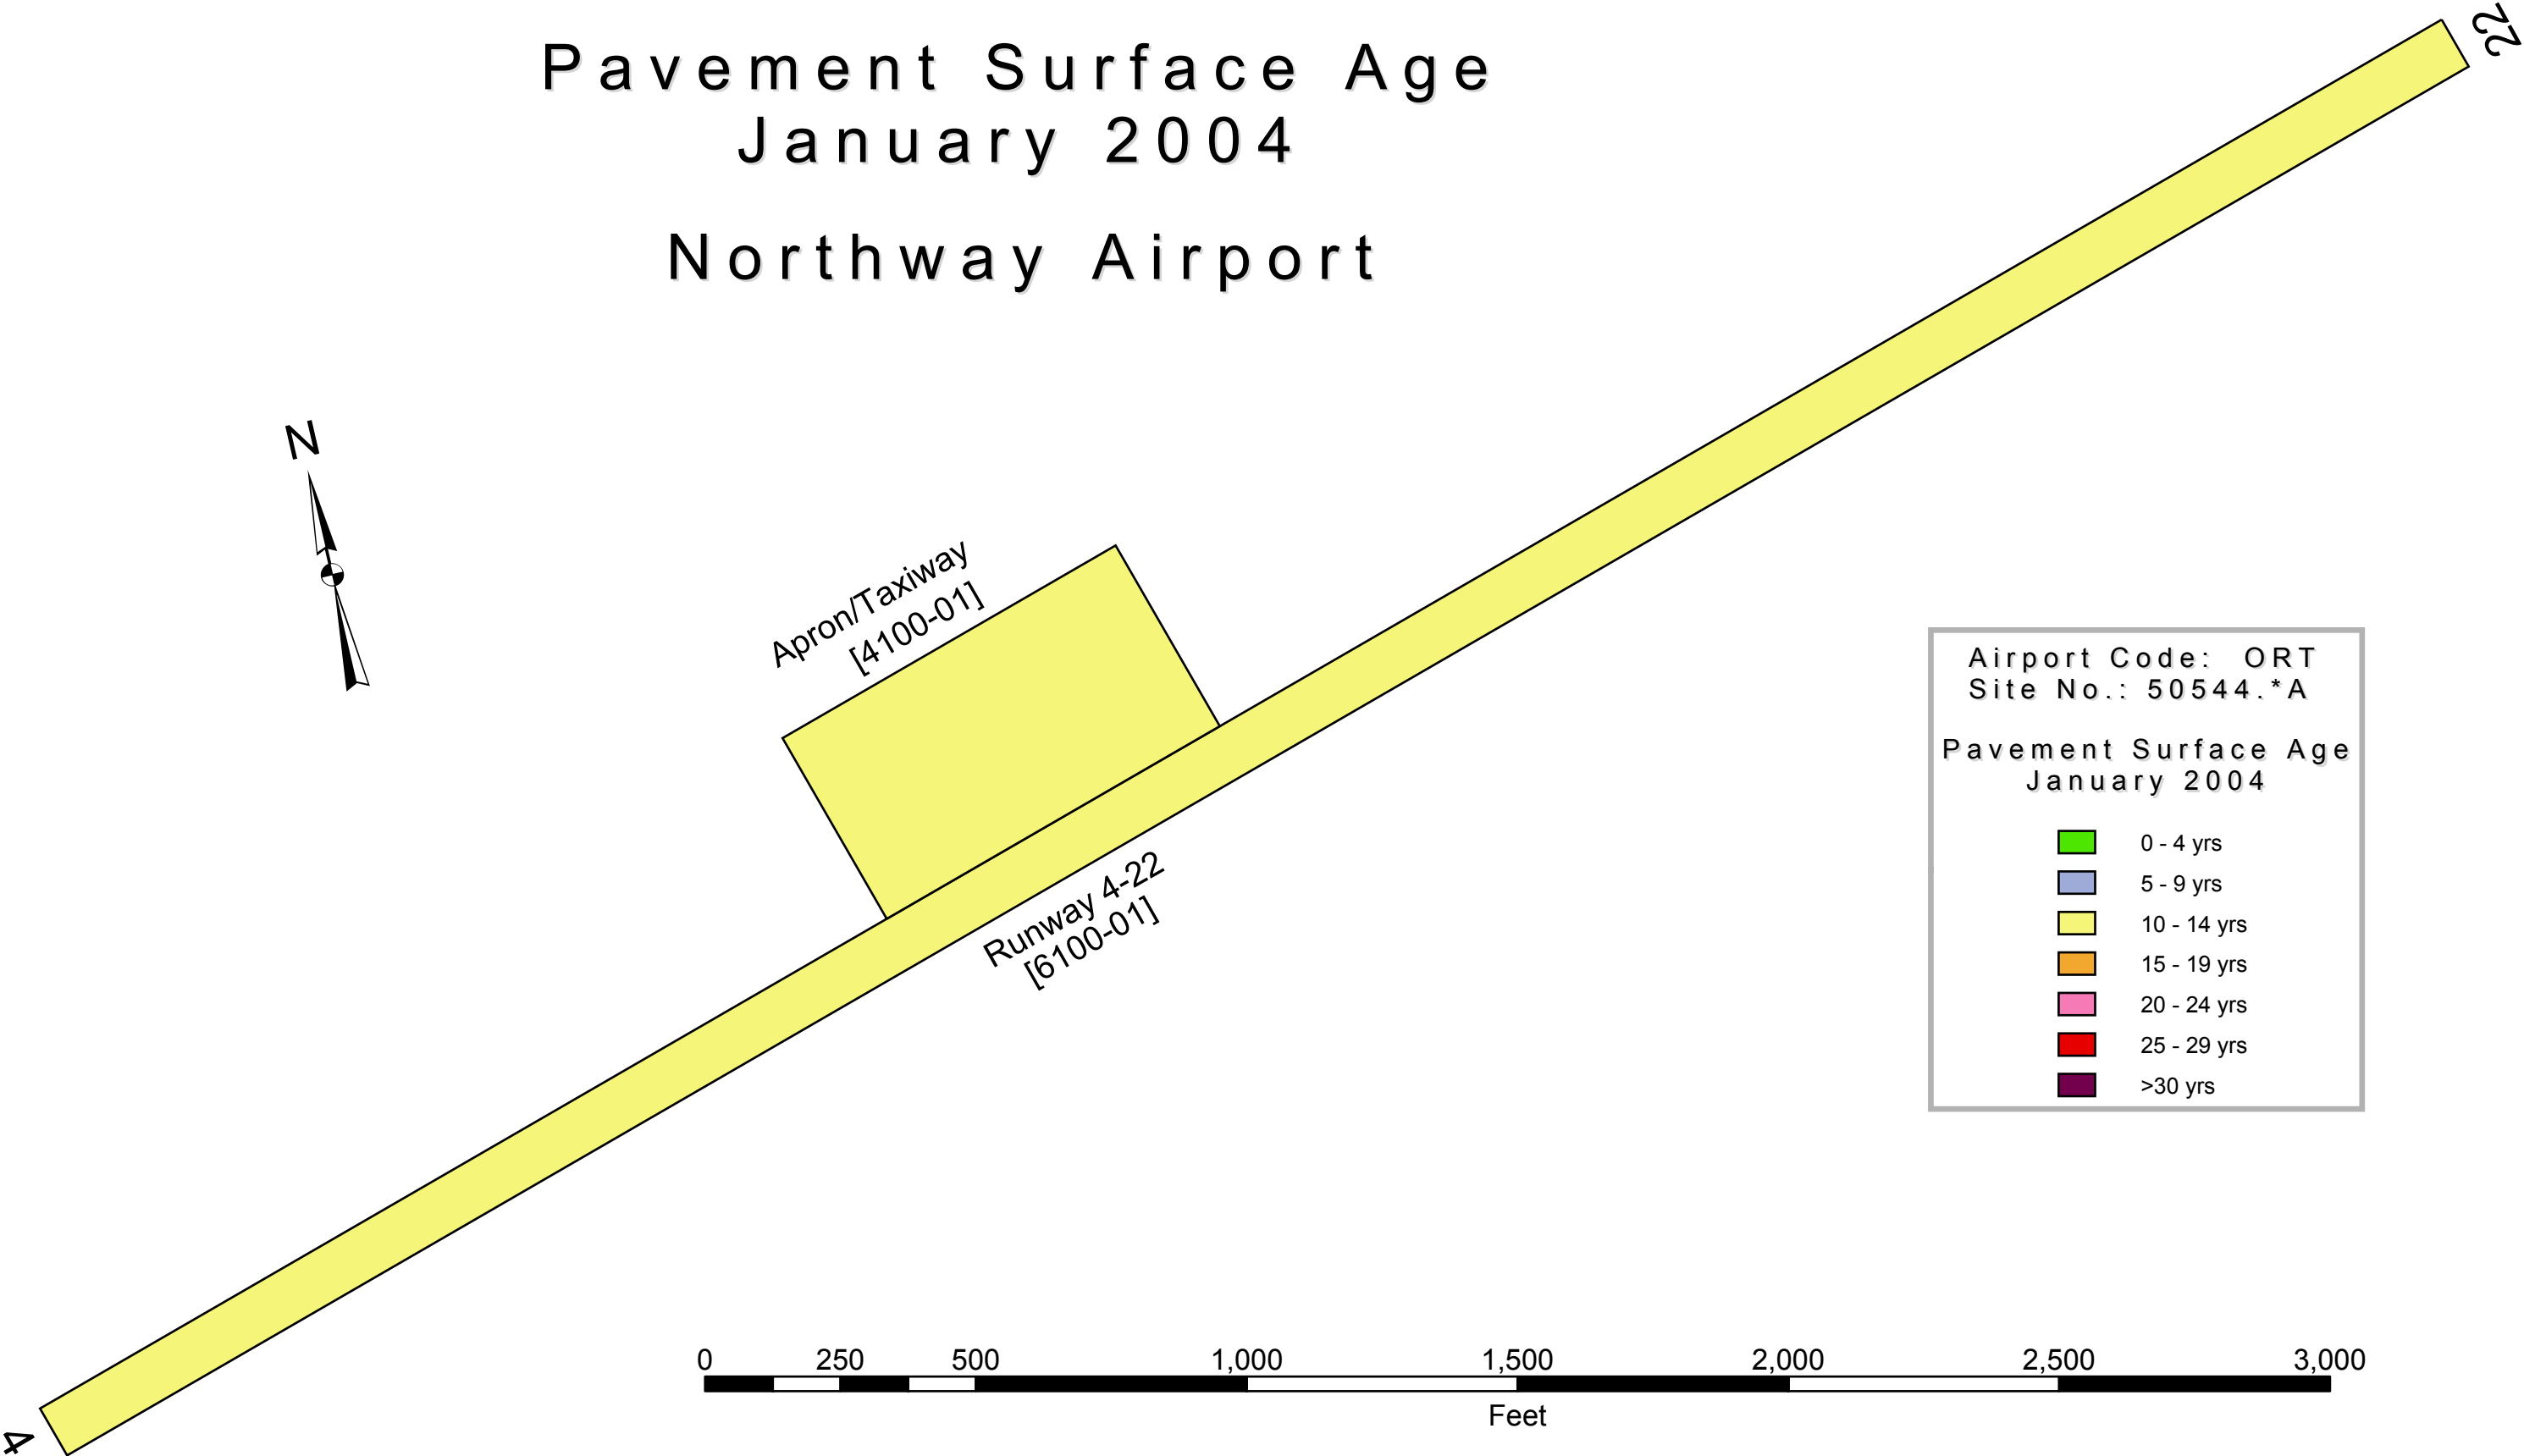
# Pavement Condition Index - PCI Measured Values for the Year 2002

- 2004 reported pavement maintenance and/or changed conditions: Due to 2002 earthquake damage the runway has reverted to a 3200' gravel strip. A reconstruction project is design.

- Recommendations: Reconstruct and pave
